HOME INSPECTION REPORT

123 Anywhere, IL 60473

Inspection Date:
7/8/2020

Report Number:
070820-01

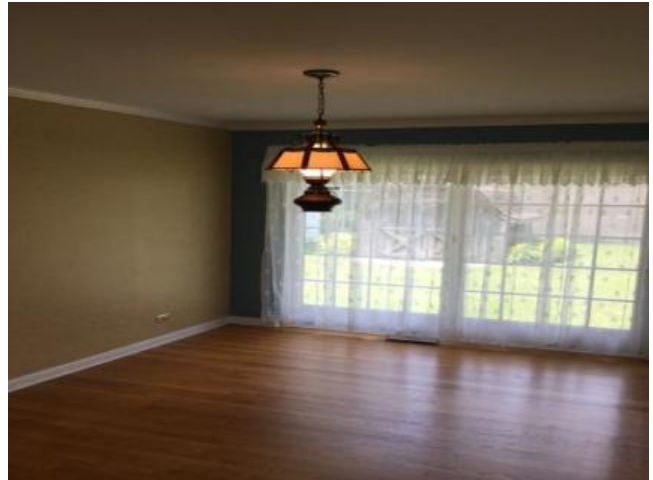
Dining Room: Outlets were tested and had open grounds or incorrect polarity. Recommend repair by a licensed electrician. Potential safety hazard.

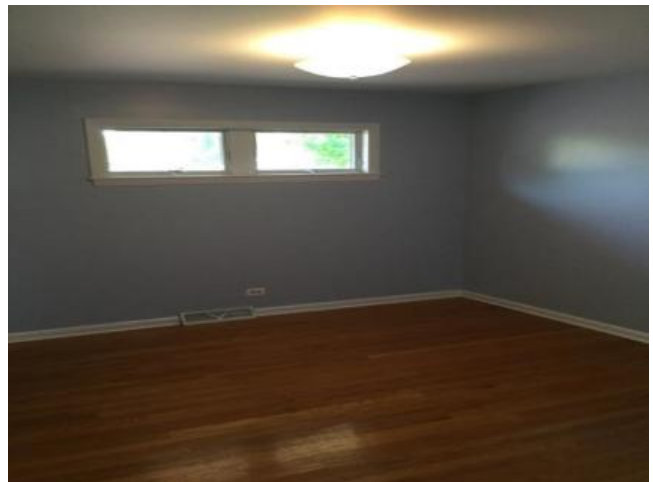
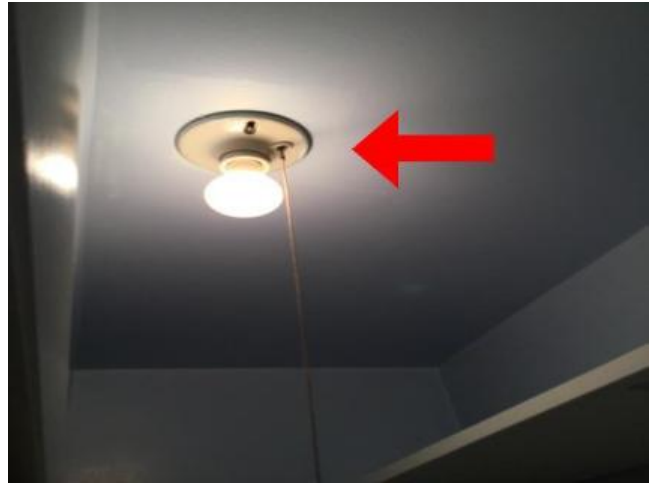
Bedrooms: Closet lights missing light fixture cover. Recommended. Potential Safety Hazard.

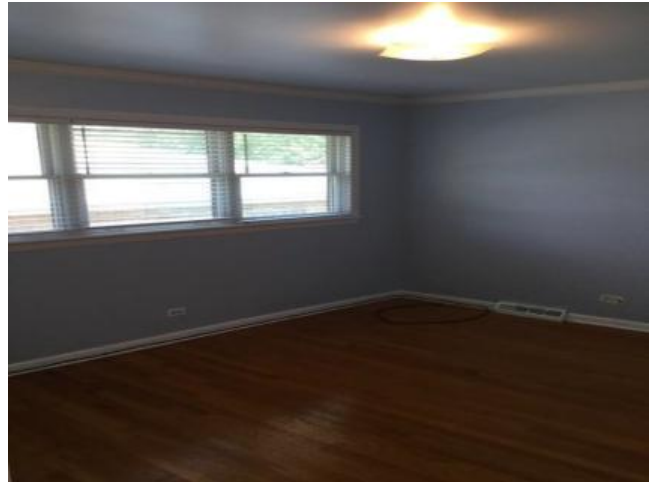
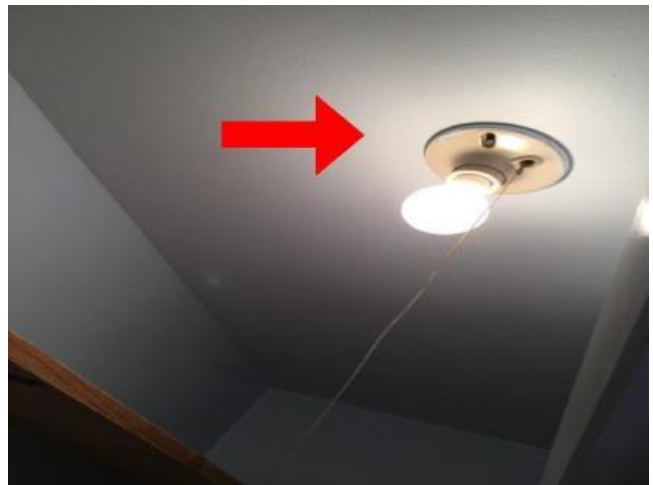
Bedrooms: Closet lights missing light fixture cover. Recommended. Potential Safety Hazard.

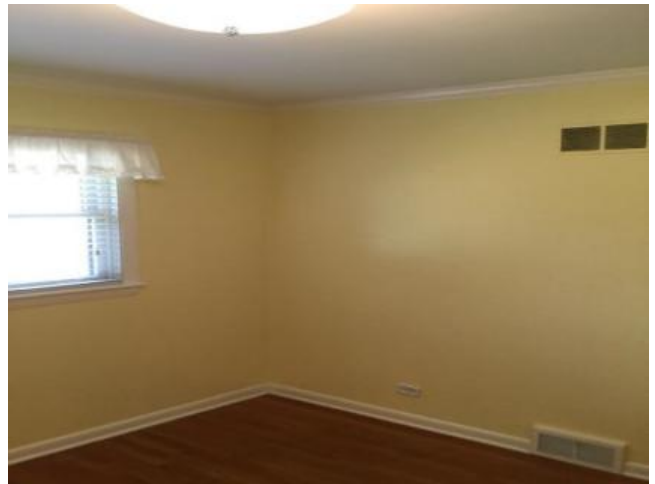
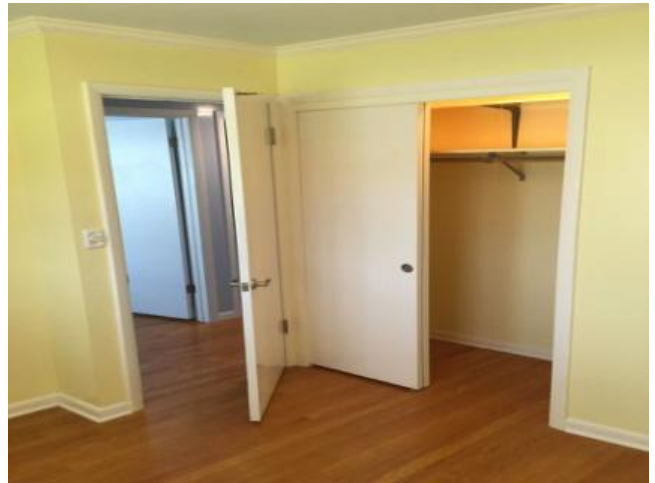
Bedrooms: Closet lights missing light fixture cover.
Recommended. Potential Safety Hazard.

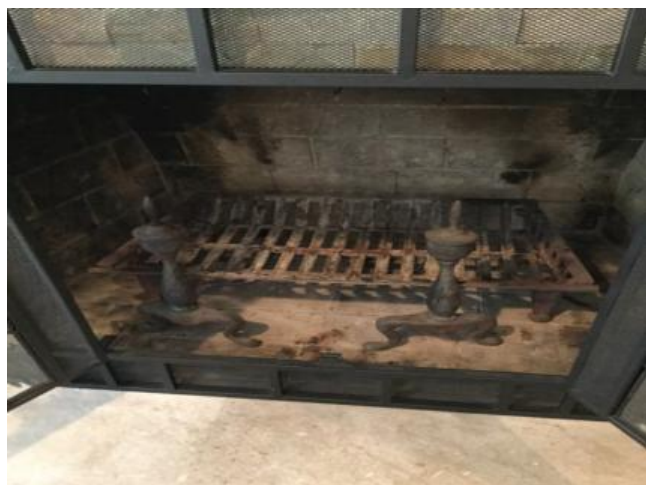
Comments: Fireplace: Recommend having the fireplace and flue cleaned before using.

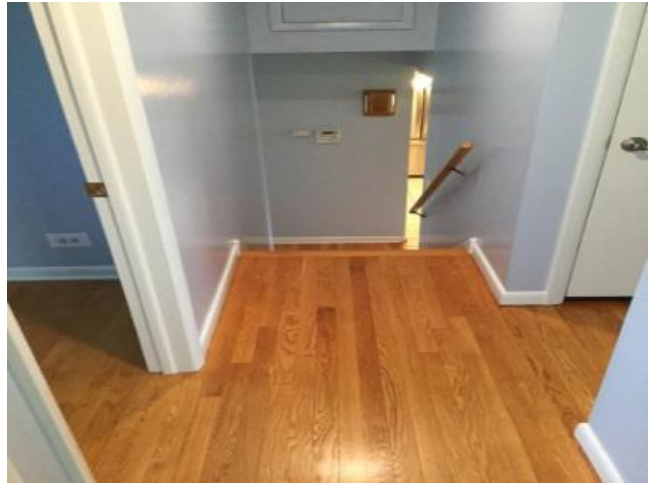
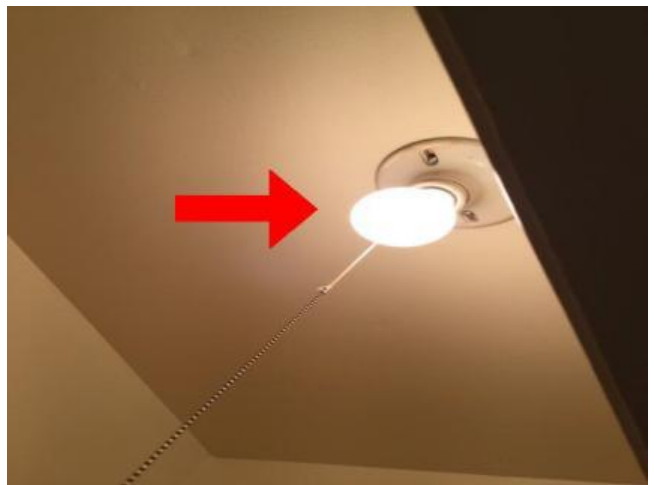
Interior: Closet lights missing light fixture cover.
Recommended. Potential Safety Hazard.

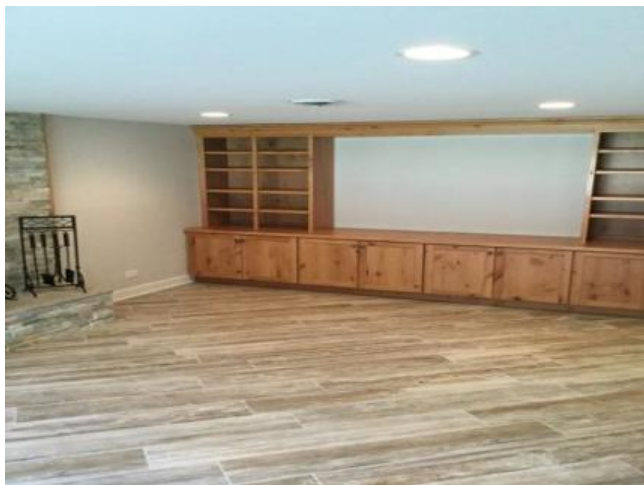
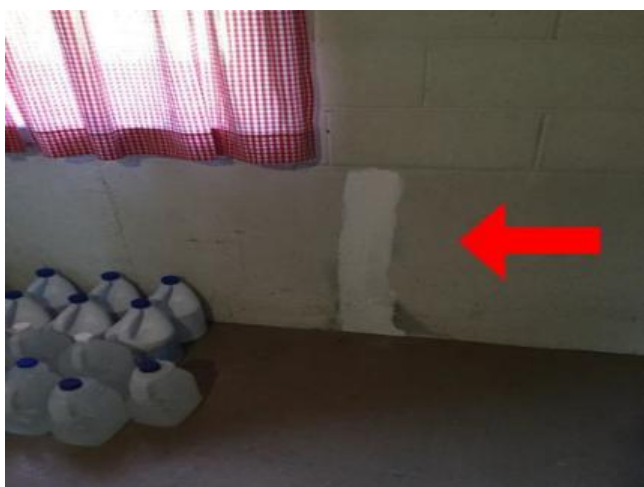
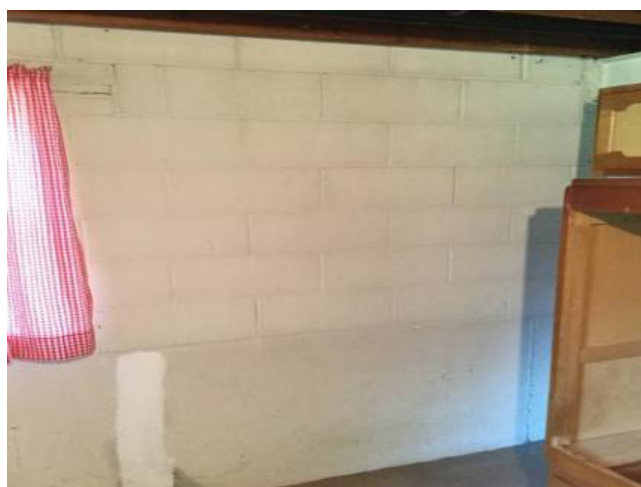
Foundation had some typical minor cracks, some had been patched. No evidence of moisture. Recommend monitoring the cracks for future movement.

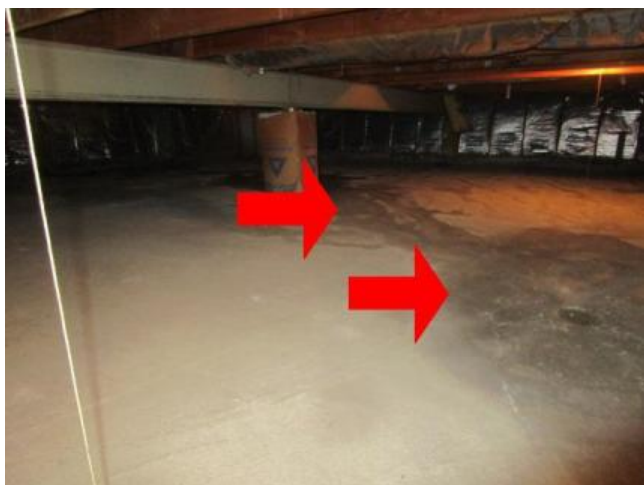
Crawl Space: Observed some moisture stains. No active moisture observed. Recommend monitoring for any changes.

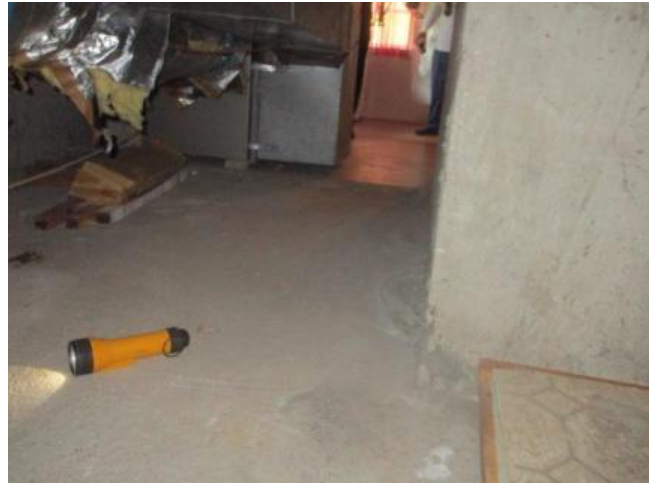
Comments: Floor appeared to be in overall satisfactory condition.
Floor had typical cracks.

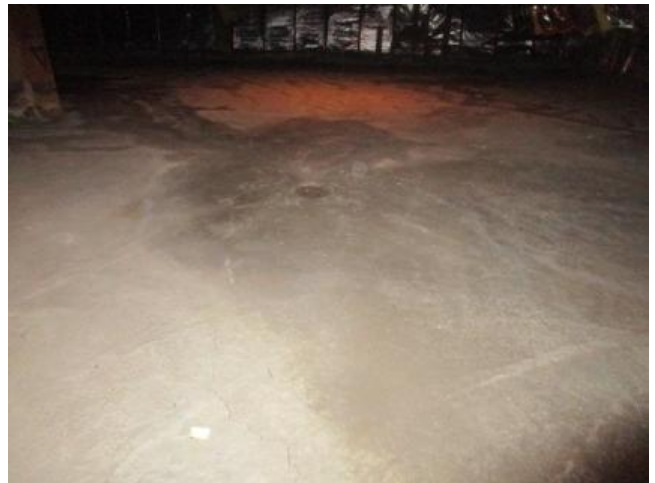
Evidence of moisture damage: Yes

Comments: Crawl Space: Recommend having a the sump pump serviced on a regular basis.
Crawl Space: Sump Pump. Recommend installing a battery backup system.

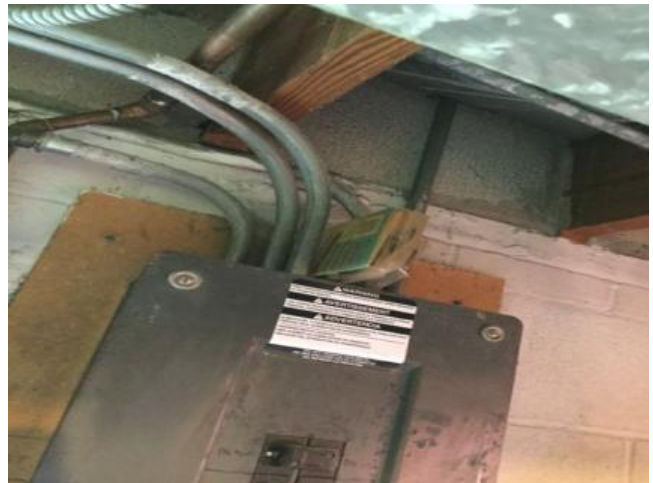
Comments: Electric service breaker panel: The panel and breakers appear to be in satisfactory condition. Panel not removed due to restricted access to the panel over the dryer.

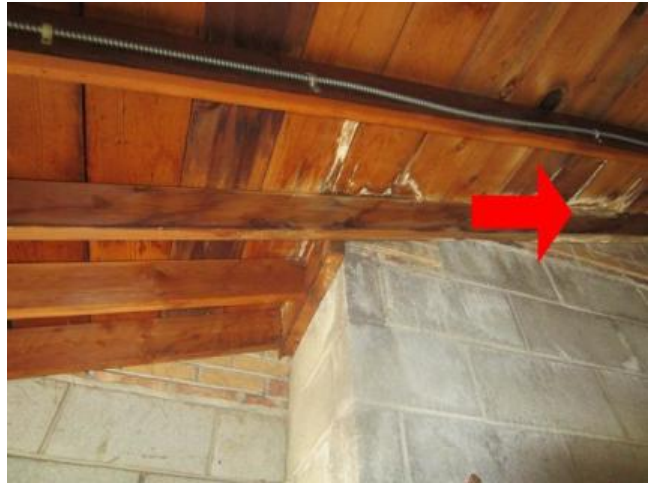
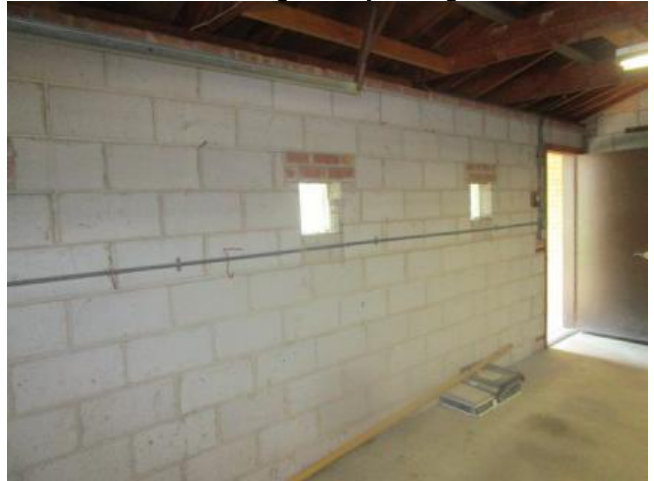
Garage: The roof has some discoloration from what appears to be old moisture stains. No active moisture observed and the exterior flashing around the chimney area appears satisfactory. Recommend monitoring for any changes.
