HOME INSPECTION REPORT

123 Anywhere, IL 60473

Inspection Date:
7/8/2020

Report Number:
070820-01

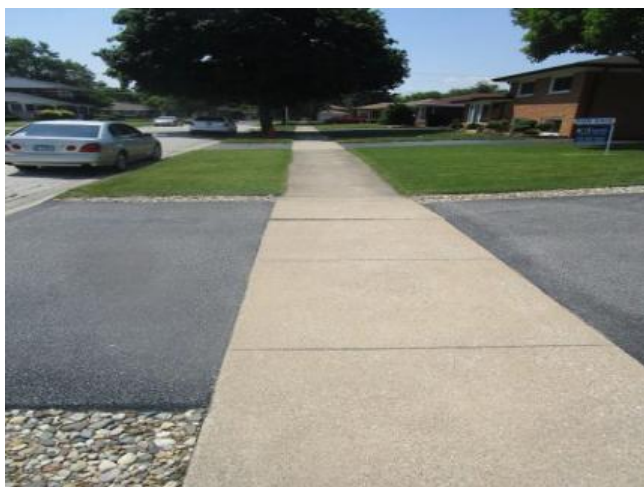
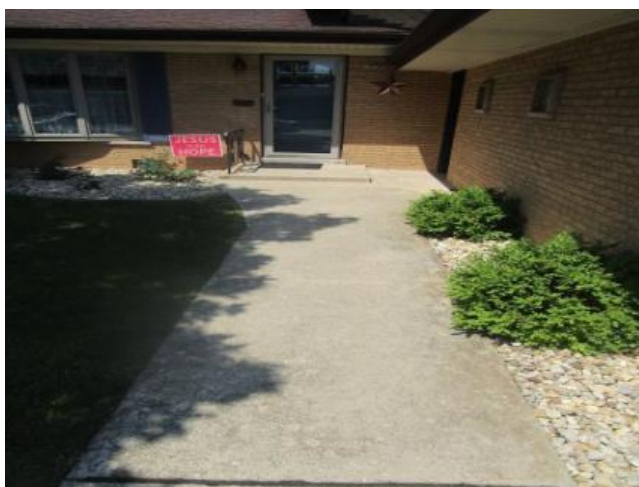
Typical cracks

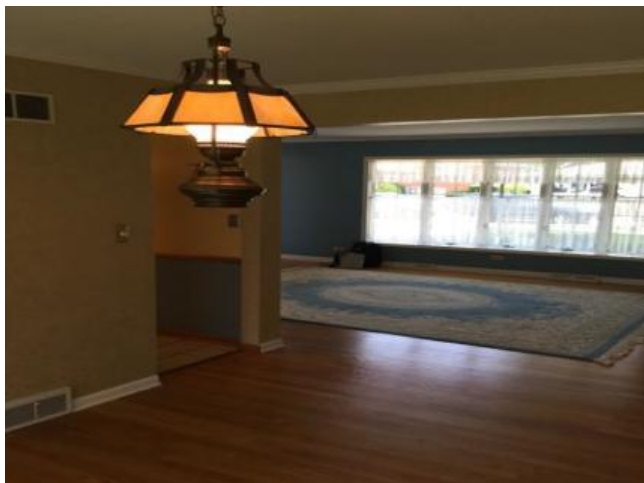
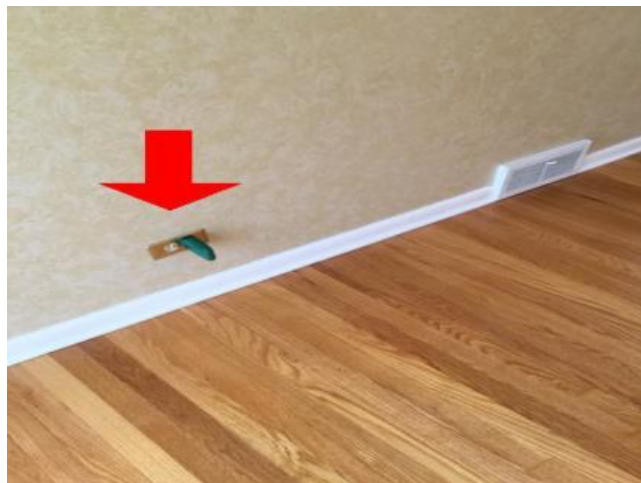
Electrical: Switches: Yes, Operable
Receptacles: Yes
Open ground/Reverse polarity: Yes
Safety hazard

Dining Room: Outlets were tested and had open grounds or incorrect polarity. Recommend repair by a licensed electrician. Potential safety hazard.

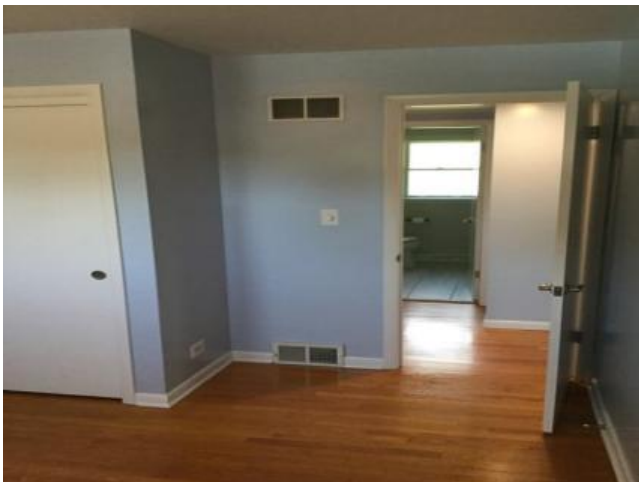
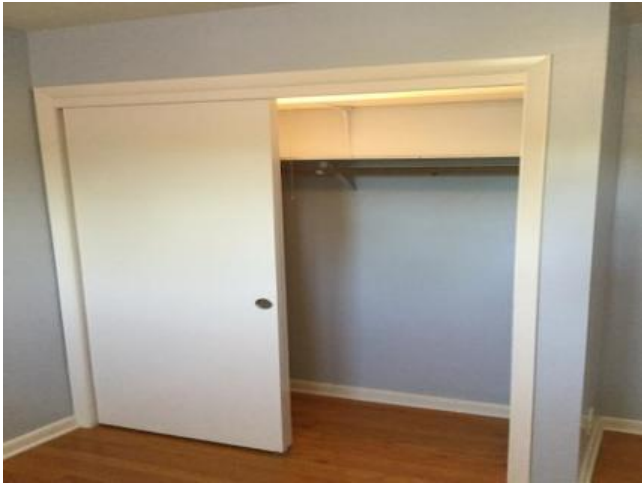
Comments: Bedrooms: Closet lights missing light fixture cover. Recommended. Potential Safety Hazard.

Bedrooms: Closet lights missing light fixture cover. Recommended. Potential Safety Hazard.

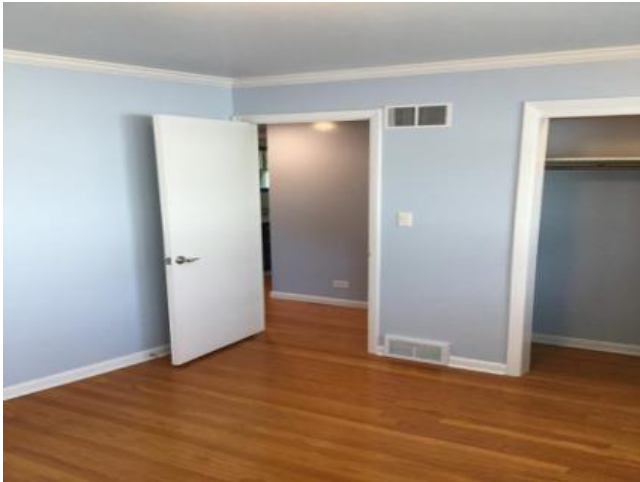
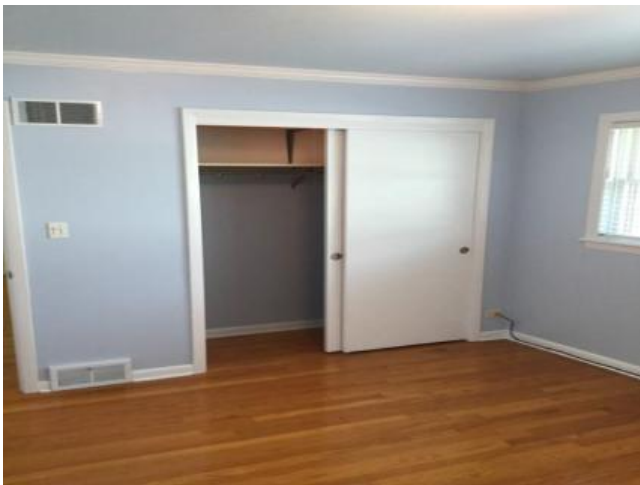
Bedrooms: Closet lights missing light fixture cover. Recommended. Potential Safety Hazard.

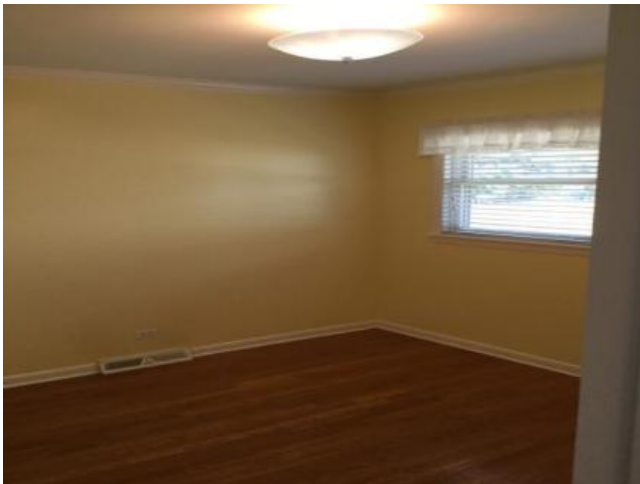
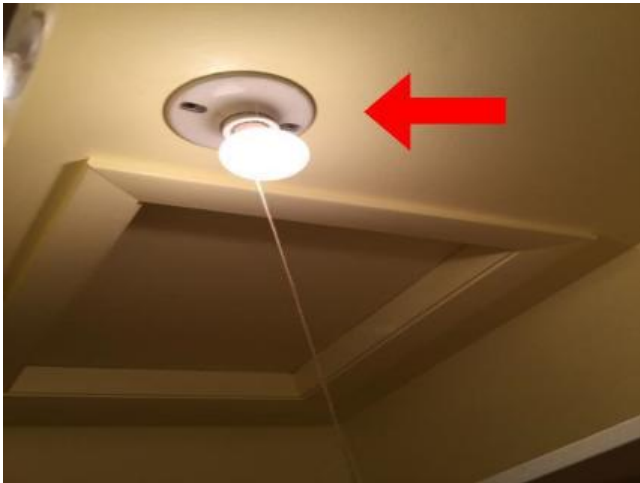
Bedrooms: Closet lights missing light fixture cover.
Recommended. Potential Safety Hazard.

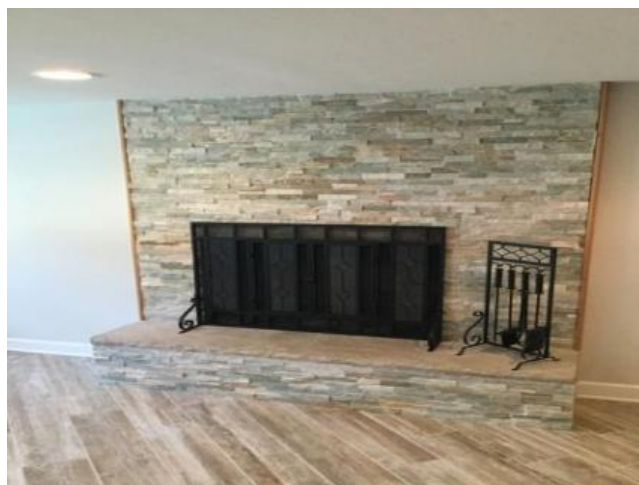
Comments: Fireplace: Recommend having the fireplace and flue cleaned before using.

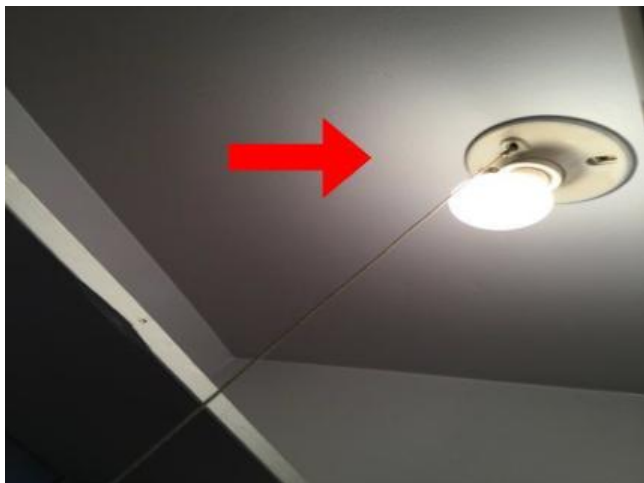
Interior: Closet lights missing light fixture cover.
Recommended. Potential Safety Hazard.

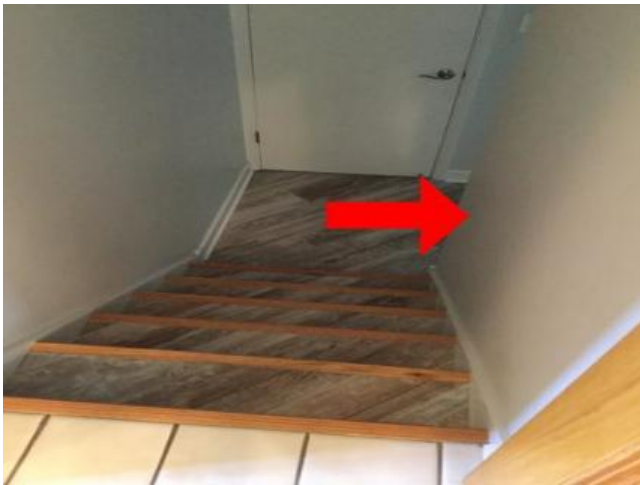
Handrail: No
Handrail/Railing/Balusters recommended

Interior: Basement stairway. Handrail missing, potential safety issue. Recommend installing handrail

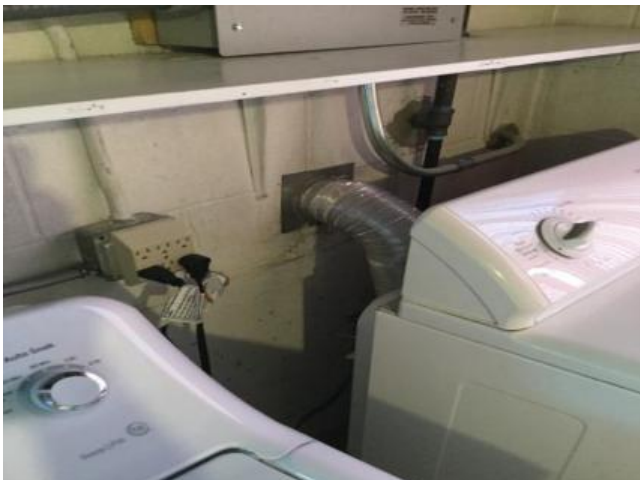
Comments: Laundry Room: Dryer vent. Recommend repairing vent to exterior. Loose.

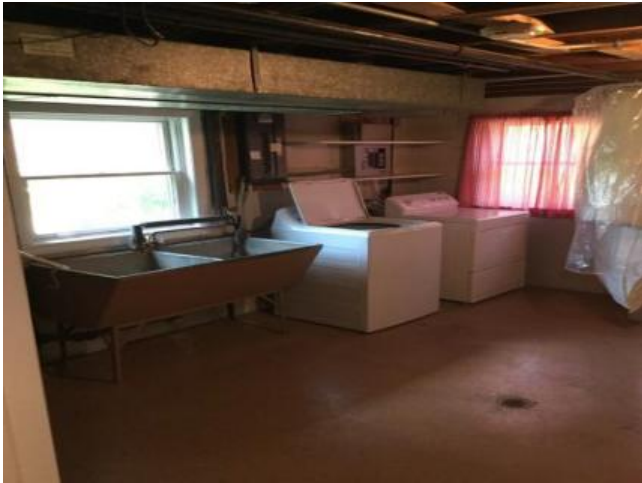
Laundry Room: Dryer vent. Recommend repairing vent to exterior. Loose.

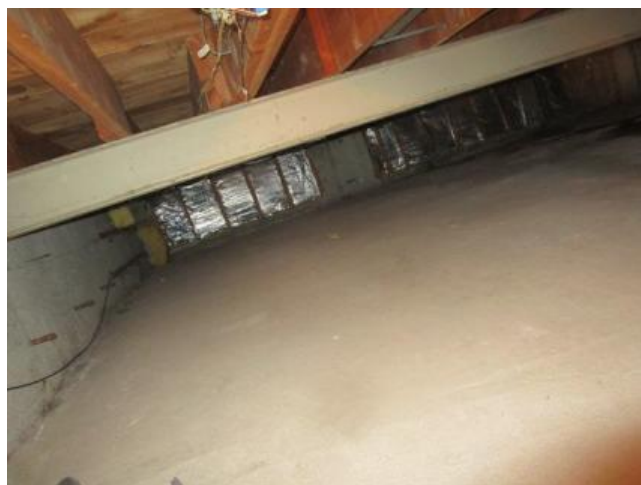
Crawl Space: Observed some moisture stains. No active moisture observed. Recommend monitoring for any changes.

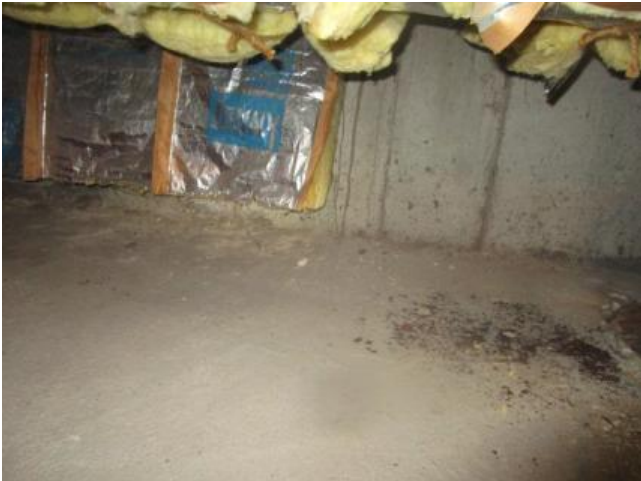
Comments: Floor appeared to be in overall satisfactory condition.
Floor had typical cracks.

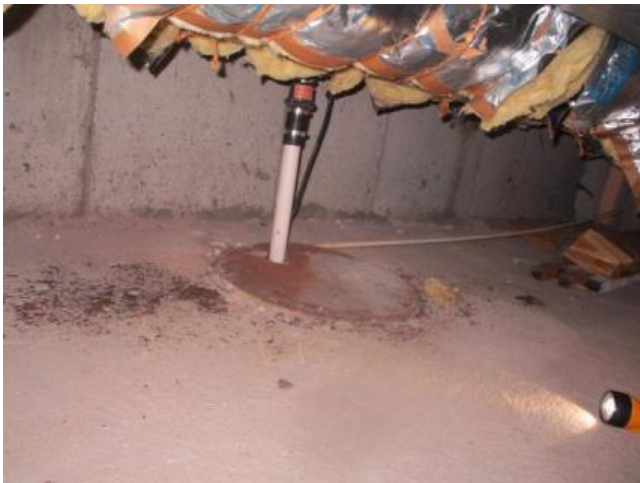
Comments: Crawl Space: Recommend having a the sump pump serviced on a regular basis.
Crawl Space: Sump Pump. Recommend installing a battery backup system.

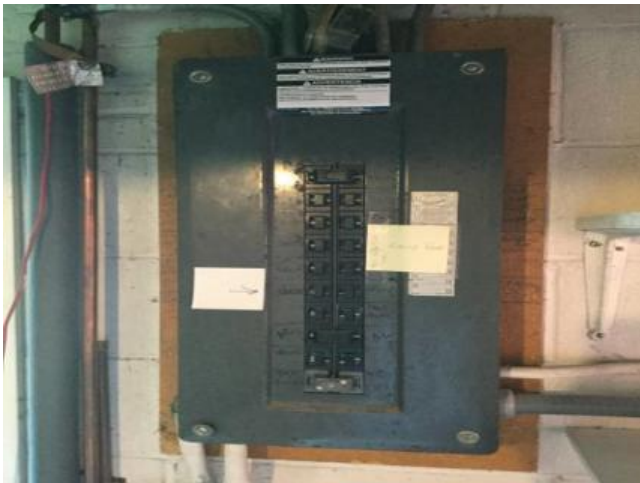
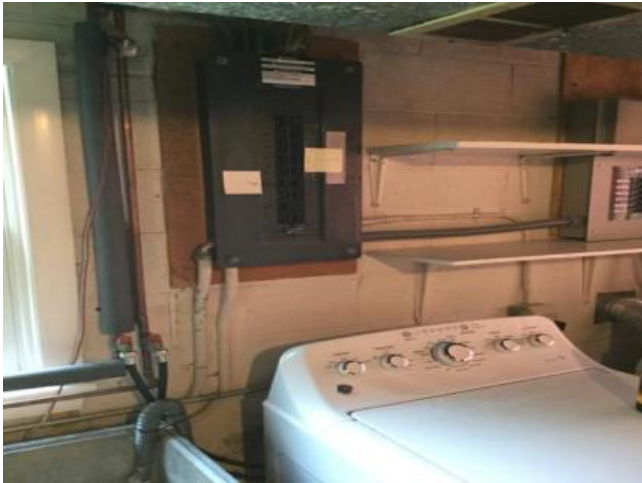
Comments: Electric service breaker panel: The panel and breakers appear to be in satisfactory condition. Panel not removed due to restricted access to the panel over the dryer.

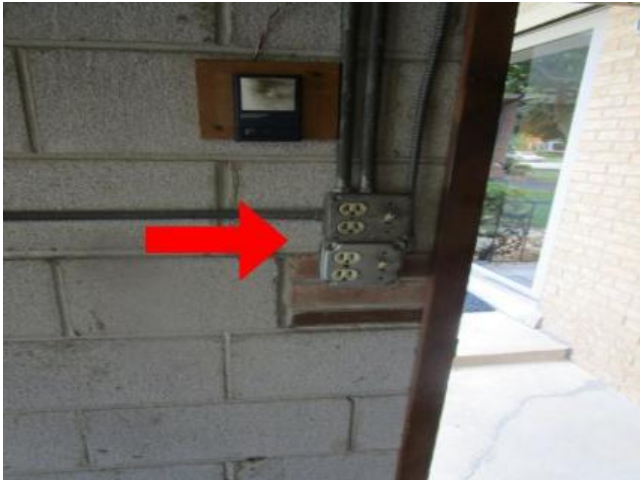
Comments: Garage: Outlets not GFCI type outlets. Recommend repair/replacement. Potential safety hazard.

Garage: Outlets not GFCI type outlets. Recommend repair/replacement. Potential safety hazard.

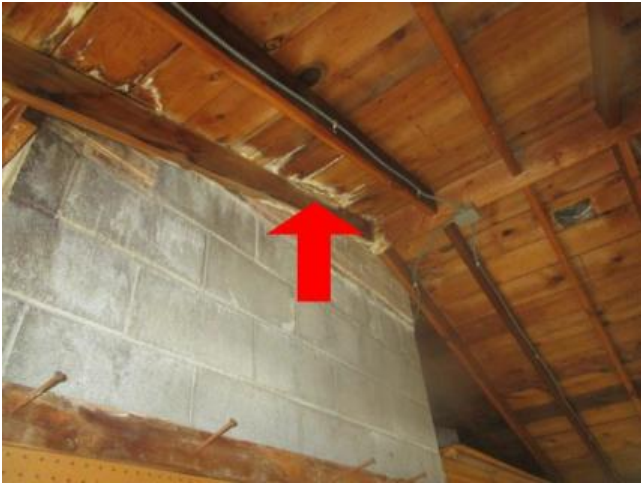
Comments: Garage: The roof has some discoloration from what appears to be old moisture stains. No active moisture observed and the exterior flashing around the chimney area appears satisfactory. Recommend monitoring for any changes.

Garage: The roof has some discoloration from what appears to be old moisture stains. No active moisture observed and the exterior flashing around the chimney area appears satisfactory. Recommend monitoring for any changes.

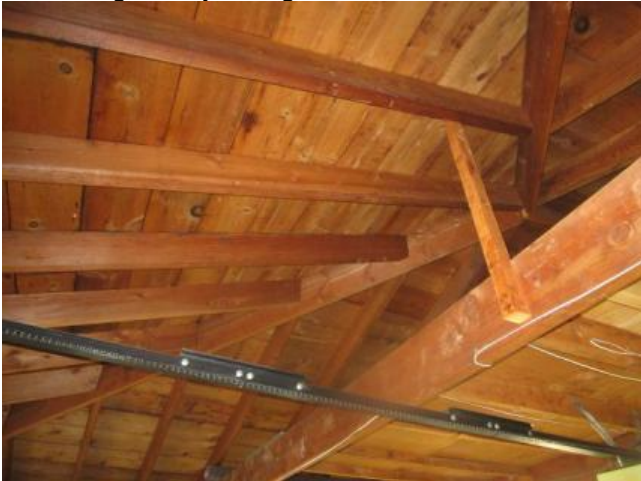
Garage: The roof has some discoloration from what appears to be old moisture stains. No active moisture observed and the exterior flashing around the chimney area appears satisfactory. Recommend monitoring for any changes.
